TAP102

DECEMBER 18

Inadequate Grease

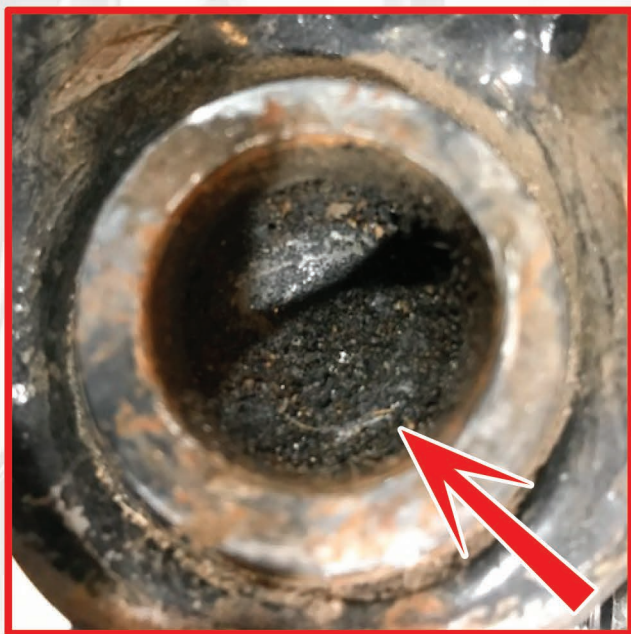
Ball Joints will wear over time. There are however certain actions that can lead to the premature wear or failure of component. These actions are as a result of incorrect installation, misuse or maintenance. A steering and suspension item is not a 'fit and forget' component. When it comes to greasable components, it is imperative that they are greased upon installation and at regular service intervals. When a greasable ball joint is not greased adequately, the hardened polished ball stud runs with too much friction against the ball joint seat, resulting in premature wear. If left un-remedied, the resultant movement, will lead to a 'knocking noise' and can result in the ball stud separating from the housing. This is readily identifiable by the dry housing, and wear marks on the ball stud ball. When you see this kind of failure it has been brought about by the inadequate servicing of the component, and is not a manufacturing fault.

Dry internals showing evidence of ball stud wear (contaminants and old dry grease).

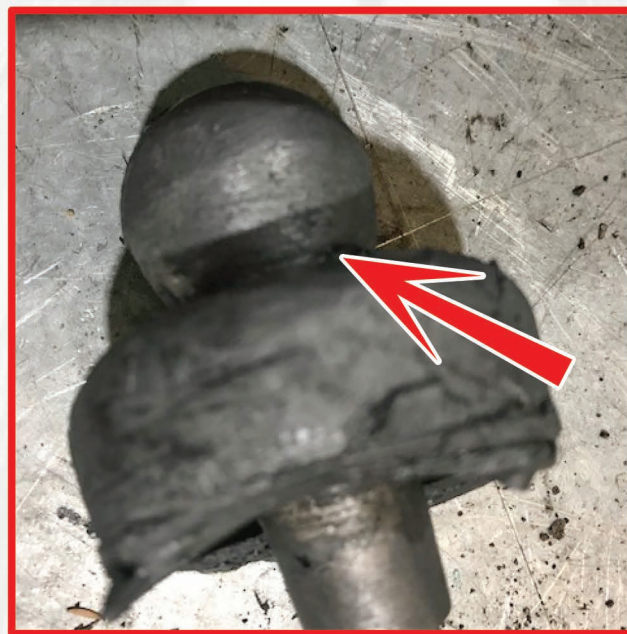
Wear marks on ball stud ball consistent with running without adequate lubrication.
