TAP104

## Loose Retaining Nut

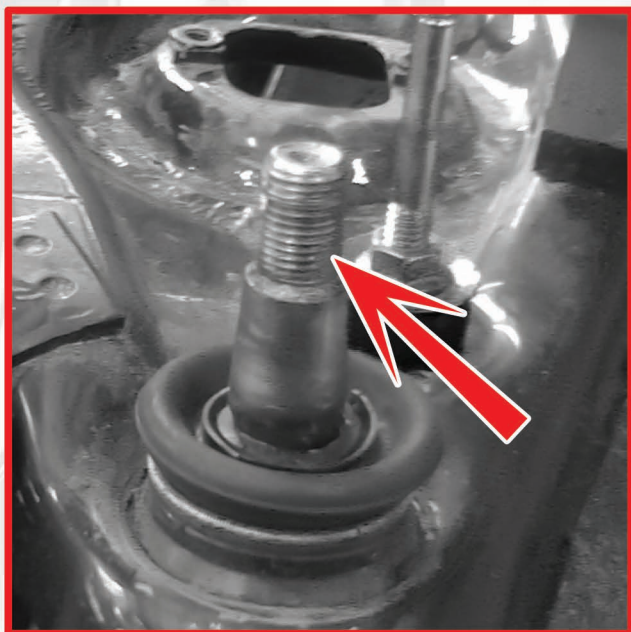
Damaged 'stretched' thread.

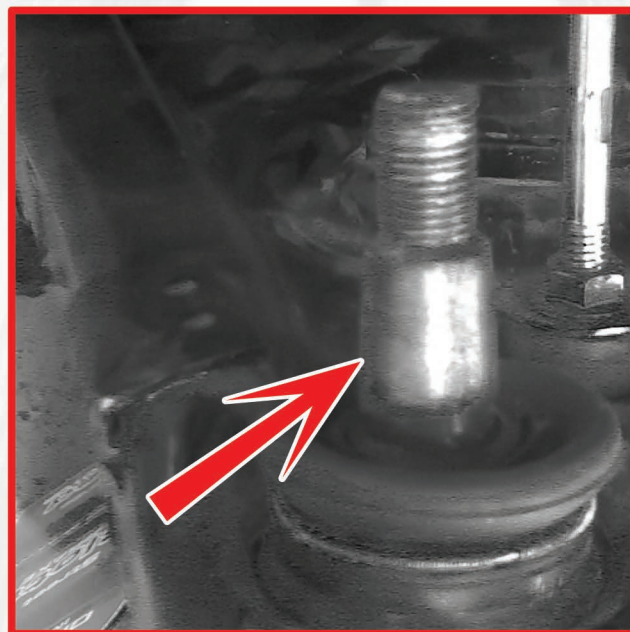
'Shiny' ball stud taper indicative of up/down movement.
