Over Articulation

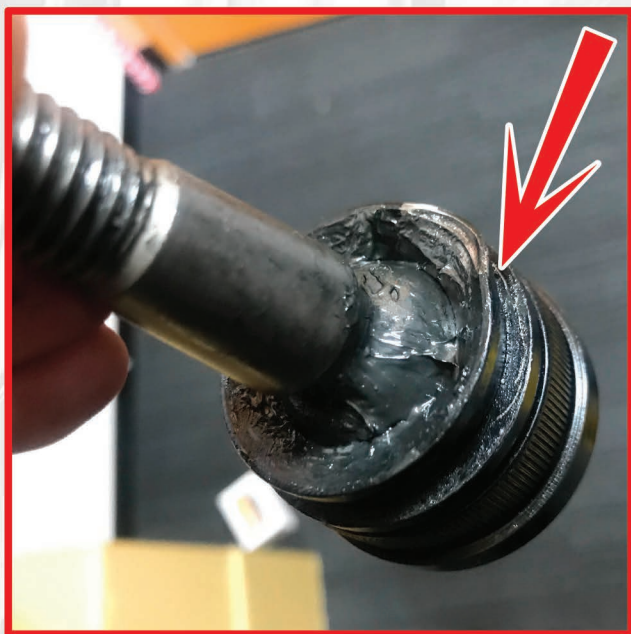
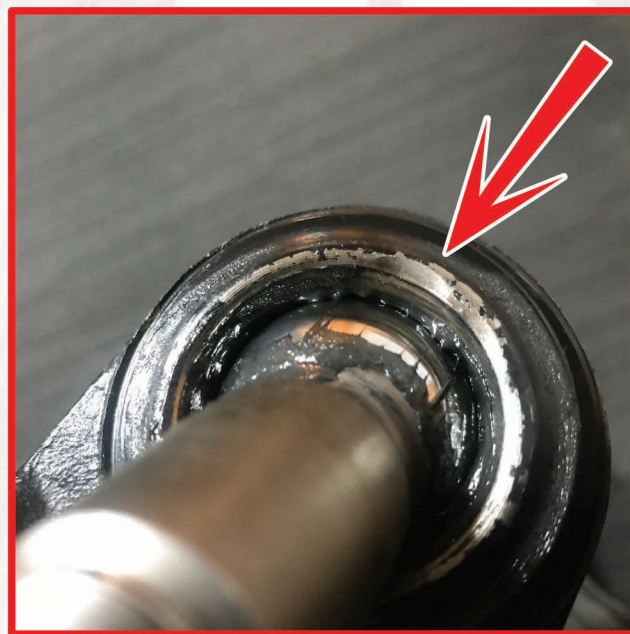
Over articulation is readily identifiable by damage to the ball joint housing and can result in the ball joint stud separating from the housing.

When you see this kind of failure it has been brought about by the incorrect selection or over articulation (possibly through misuse) of the component, and is not a manufacturing fault.

Clear evidence of over articulation where the ball stud has made contact with the ball housing.
