TAP107

Ball Stud Separation

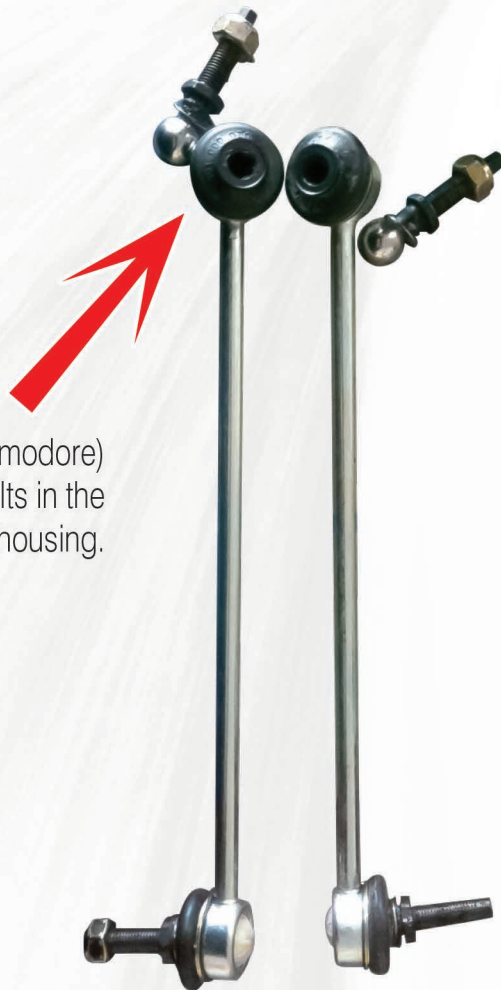
Some Sway Bar Links are handed, meaning they have side specific fitment. It is imperative that the links are fitted to the correct side of the vehicle, in the correct orientation. Incorrect installation can lead to the ball studs separating from the housing. When you see this kind of failure it has been brought about by the incorrect selection or installation of the component, and is not a manufacturing fault. This type of failure is readily seen with STB8822/23 (VE Commodore) Sway Bar Links.

STB8822/23 sway bar links (VE Commodore) fitted to incorrect side of vehicle results in the ball studs separating from the housing.
