## TOW POINT INSTALLATION

### RP-RAN02: FORD PX3 RANGER & EVEREST 06/2018-0N

Applicable to vehicles manufactured post - JUNE 2018.

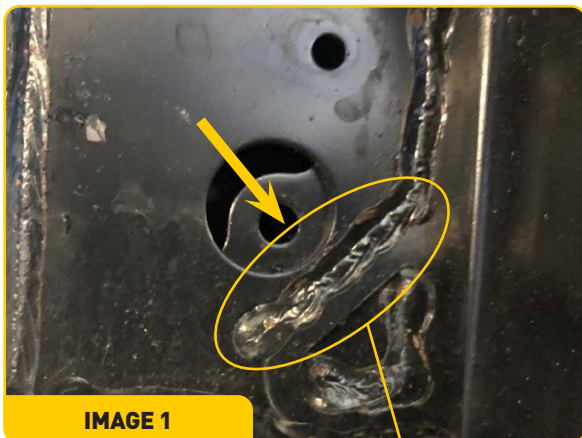
A stiffening plate installed inside the chassis rail affects access to one hole used in the fitment of RP-RAN02 (refer to image 1). Using a step drill, enlarge this hole to allow fitment of the supplied hardware. The spacer pictured will require modification to clear the new weld not present on previous vehicles.

The nut plate will sit behind the stiffening plate, with the bolt passing through.
