RAP502A - March 2018

## **BJ3562L & BJ3562R**

### **HILUX LOWER BALL JOINTS**

### **NEW PAIR PACK - BJ3562PAIR**

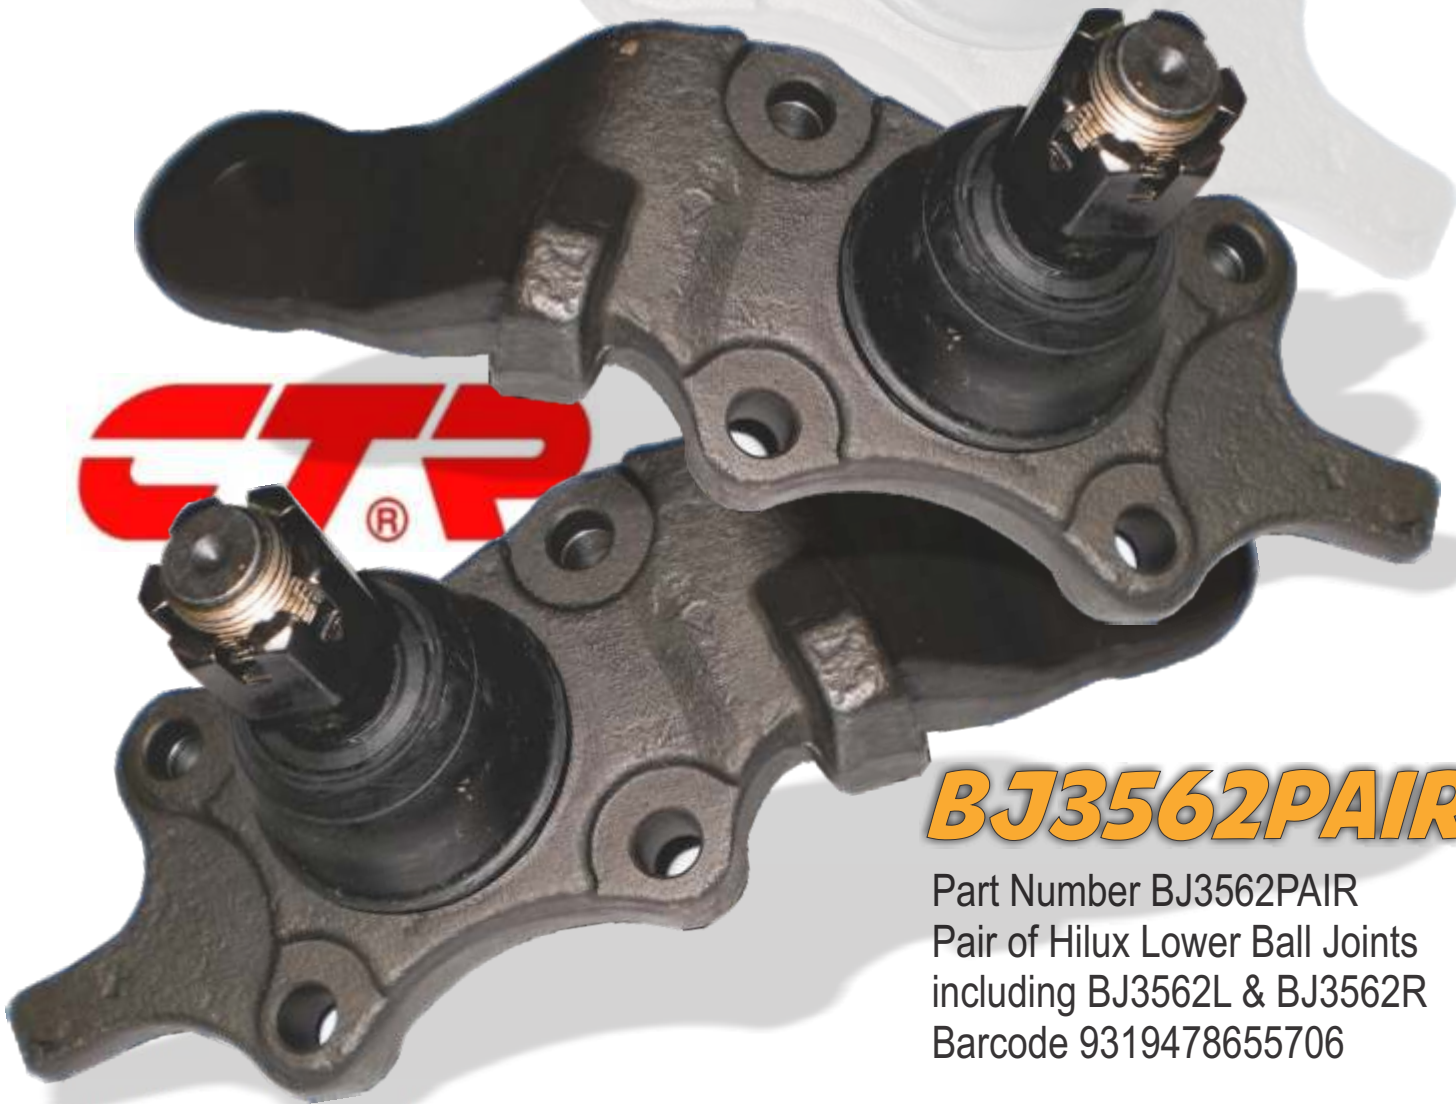
### **BJ3562PAIR**

Part Number BJ3562PAIR  
Pair of Hilux Lower Ball Joints  
including BJ3562L & BJ3562R  
Barcode 9319478655706

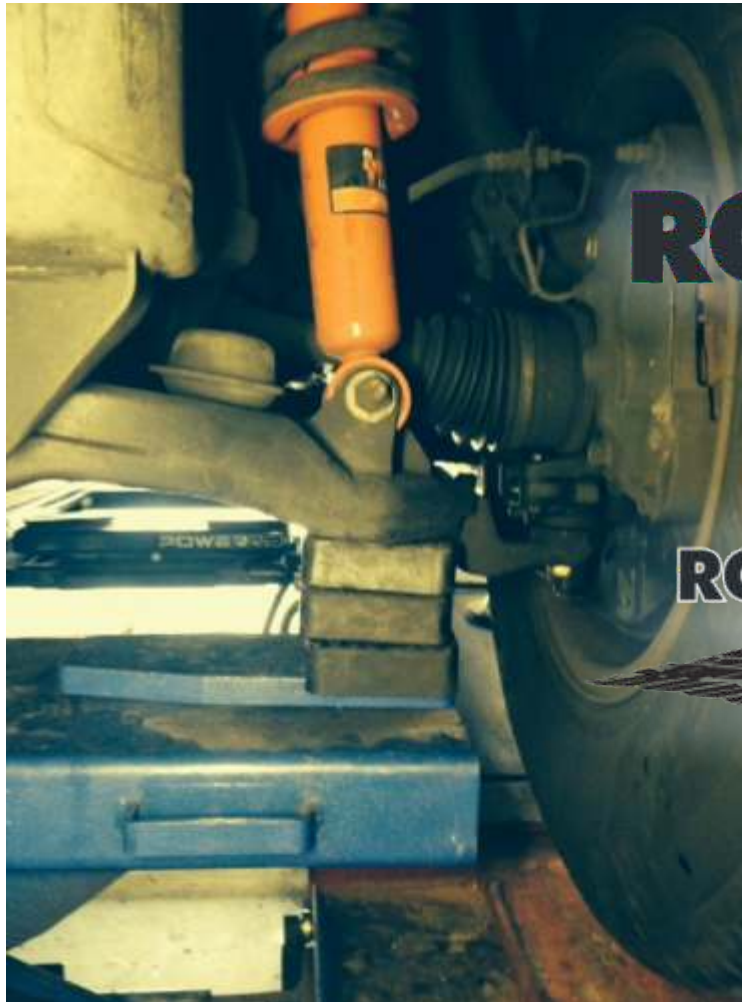
# Correct Jacking Position for BJ3562L & R Hilux/Prado 90 Series Lower Arms (strut front end with coil over suspension) for Testing Lower Ball Joints

The correct jacking method to test the lower ball joint on the Hilux/Prado 90 Series is to jack from the control arm at the point as close as possible to the ball joint. This loads the joint and is where the lateral (sideways) and vertical (up & down) movement is tested. If lateral (sideways) movement in the joint is detected (using the correct jacking method) this indicates an unserviceable joint. Vertical movement of 1 to 1.5mm is acceptable in this mechanical designed load carrying ball joint. If vertical movement greater than 1.5mm is detected this could indicate an unserviceable joint.

If the car is jacked from the cross member, this unloads the joint, and in this situation, 1 to 1.5mm vertical movement will be readily visible. This vertical movement is acceptable in this mechanical designed, load carrying joint. You cannot accurately check for lateral movement in the joint using this jacking method.
