**VEHICLE** Toyota Landcruiser 76/78/79 Series  
**PRODUCT** Rated Recovery Point  
**PRODUCT CODE** RP-CRU70EV2

**DURING RECOVERY ALWAYS USE A BRIDLE STRAP CONNECTED TO BOTH RECOVERY POINTS**

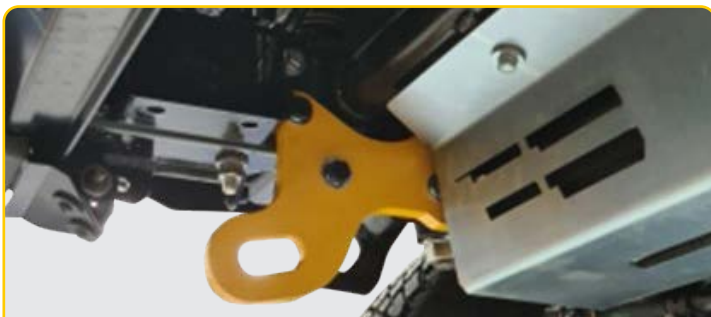
Figure 1 - Drivers side recovery point

1. The Mounts themselves are sided, so please ensure installation to the correct side of the vehicle. After removing the undertray or bash plate undo the lower front steering box bolt and position plate as per figure 1.

2. On the driver's side, use the M12 x 120mm bolt and 25mm x 9mm (see note) spacer to replace the factory steering box mounting bolt. Use 2 M10 x 60mm bolts for the 2 lower holes which are spaced from the chassis and the M10 x 40mm for the hole against the chassis.  
*Note: The M12 x 120 mm bolt and 25 x 9 mm spacer are not required on ANCAP rated Single cab 79 models.*

3. There are two different thickness washers to account for different front bar mount brackets, it is the discretion of the fitter to ensure the recovery point is evenly contacting the chassis rail at all points.

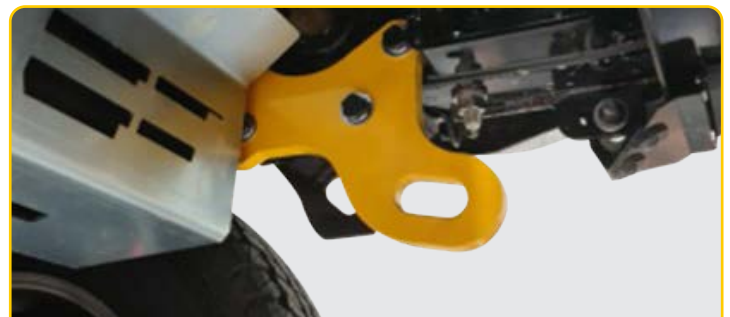
Figure 2 - Passengers side recovery point

4. Continue to the passenger side, positioning the plate as per figure 2. Insert the crush tube and the M10 x110mm bolt into the top-rear mounting hole (see note), again use 2 M10 x 60mm bolts for the 2 lower holes which are spaced from the chassis and the M10 x 40mm for the hole against the chassis.  
*Note: The crush tube, M10 x 110 mm bolt and 25 x 9 mm spacer are not required on ANCAP rated Single cab 79 models.*

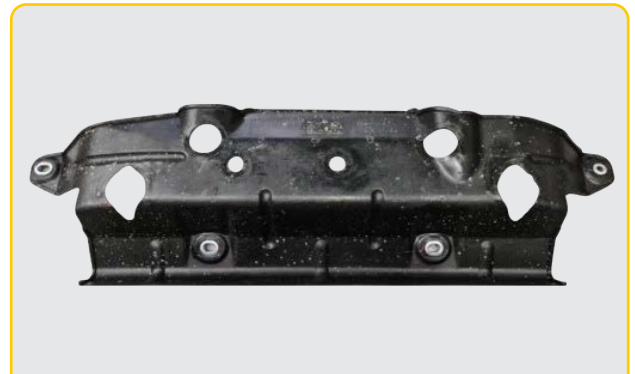
Figure 3 - Notching of plastic undertray

9. Ensure all supplied and specified components are used during the installation of tow recovery points. Failure to do so will significantly reduce the Working Load Limit (WLL) specified for each individual point, which can result in serious injury or death.
7. The RP-CRU70E have been designed to protrude next to the Roadsafe Skid Plate as shown in the images 1 and 2 above. With some aftermarket skid plates you might need to trim two 100mm (long) x 40mm (wide) holes on each side to allow for the skid plate to be refitted. For the original Toyota undertray 2 small notches need to be done as per figures 3 and 4.
8. Single cap ANCAP Rated fitments only: The power steering lines on the drivers side of the vehicle need to be adjusted to have clearance to the recovery point. The clamps holding the pipes can be loosened and the pipes adjusted and then retightened.

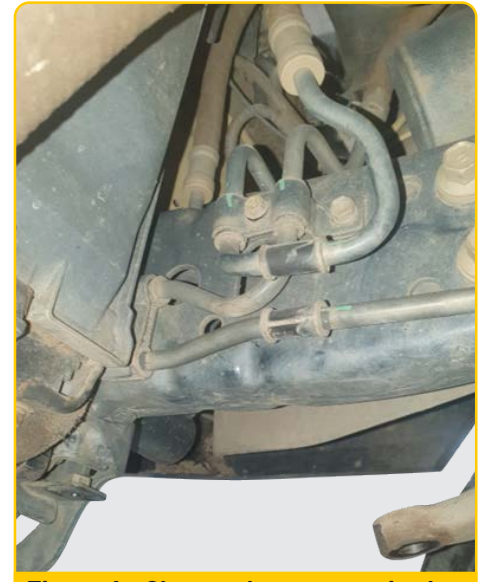
Figure 6 - Clamps that are required to be undone so the lines can be adjusted.  
SINGLE CAB ANCAP ONLY
