# Landcruiser Front Diff Drop Kit

**Part Number: LCRDD**

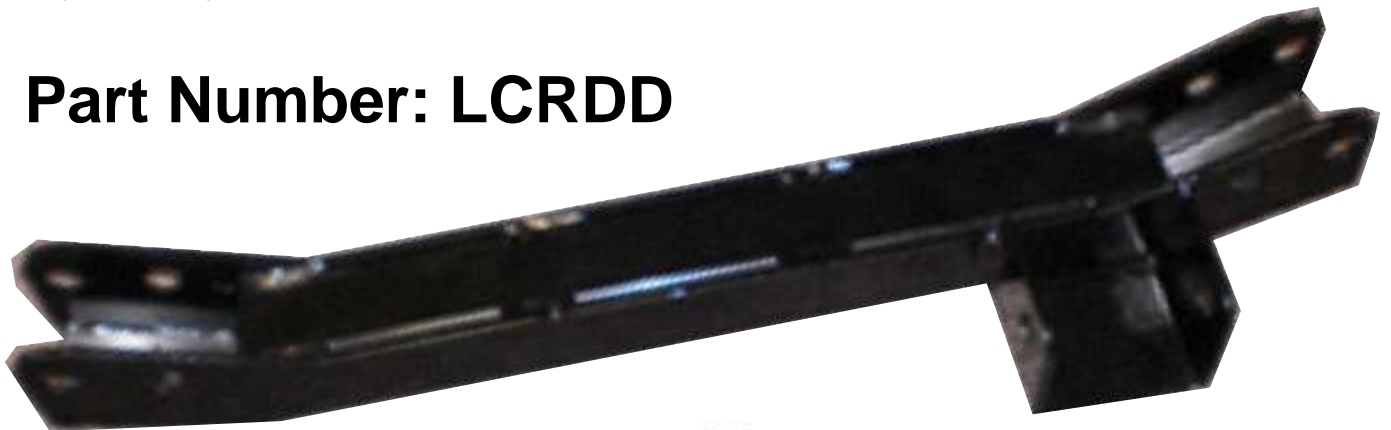
The Roadsafe IFS Diff Drop Kit is supplied complete with replacement cross member and fitting kit. The bolt on kit corrects the geometry on the front driveshaft and cv's, lowering the front diff by approx. 25mm, thus reducing the angles the CV joints need to operate on, and avoiding the expensive replacement of CV's and boots.
