Extended Ball Joint Hilux 05-on Upper

BJ4081

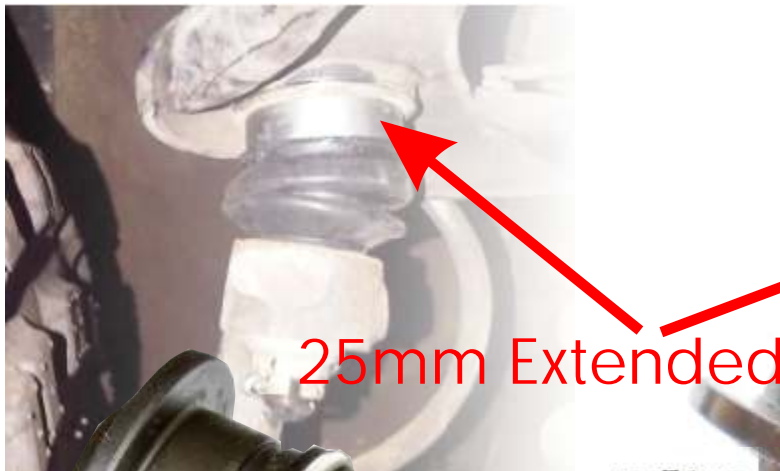
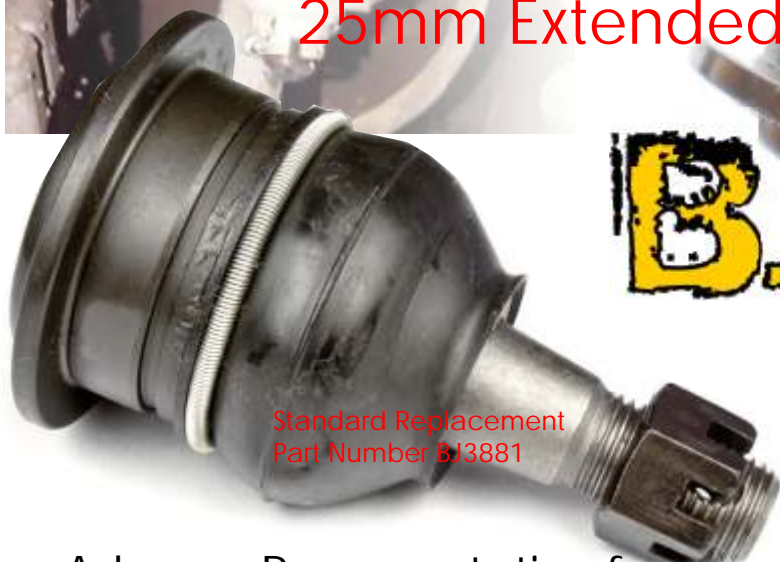
If you have a lifted 05-on Hilux and during articulation you hear a clunk during full articulation, it might be the Front Upper Control Arm making contact with the Coil. Roadsafe have a 25mm extended Upper Ball Joint that fits to the Upper Control Arm, to space the arm far enough to avoid the factory upper arm contacting the coil on full droop. As an added bonus, it also provides an extra inch of downward travel, plus improves caster.
