# Nissan Patrol GQ & GU Rear Coil Reinforcing Bracket

**SB003**

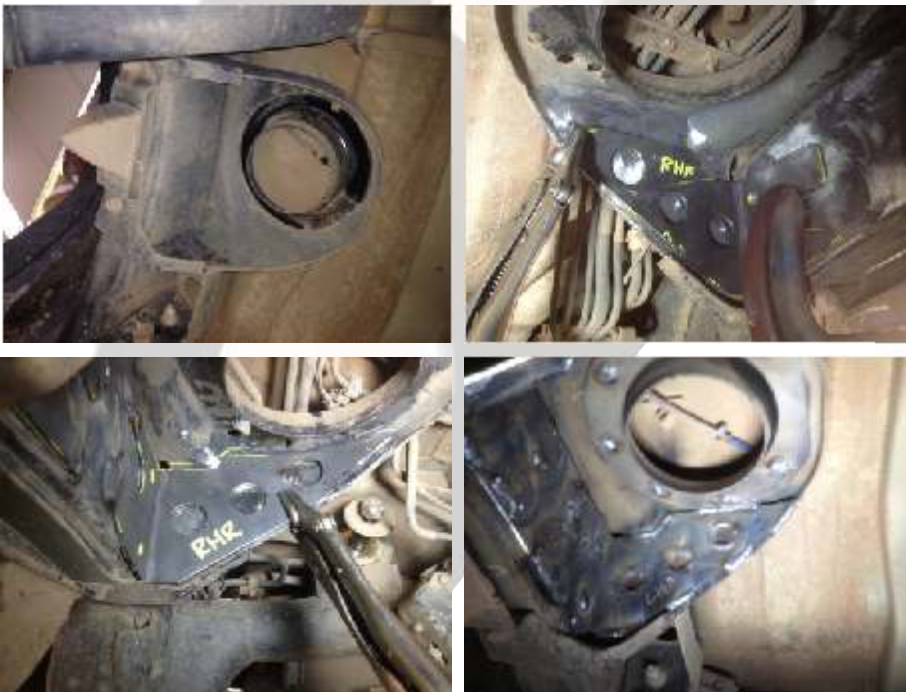
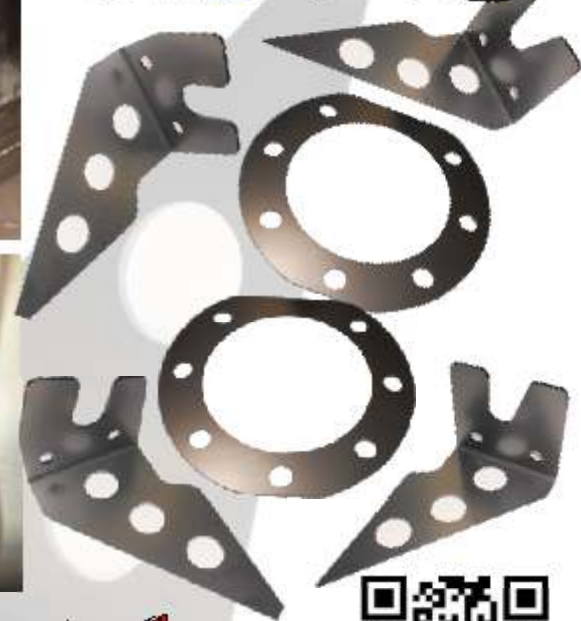
GQ & GU Nissan Patrols are known to have issues with their rear coil towers. When the vehicles are used extensively off road, this issue is emphasised. In vehicles that are heavily laden, it is common for the rear coil tower brackets to crack, and possibly even tear away from the chassis rail. This results in a number of severe implications including... Vehicle leaning to one side, torn chassis rail, possible cracks in chassis rail, ruptured brake lines (resulting in brake failure) plus diminished handling capabilities. Roadsafe 4WD have designed this SB003 six piece kit (3 pieces per side) to be welded into place, inside the existing tower, to reinforce the factory coil tower to assist in both avoiding initial failure or fixing failures that are evident. In some instances where a repair is required due to cracked/broken coil tower, and the existing damage requires fixing, it is easier to affect the repair by installing the SB003 kit simultaneously. Approx. Install time on basic install allow between 3-4 hours (some trimming of the kit plates will be required - to ensure plates fit tight to existing coil tower)
