BJ3881 now available Greasable Hilux 05-on Upper Ball Joint

Part Number **BJ3881HD**
Description **Hilux 05-on Upper**
Barcode **9319478607941**

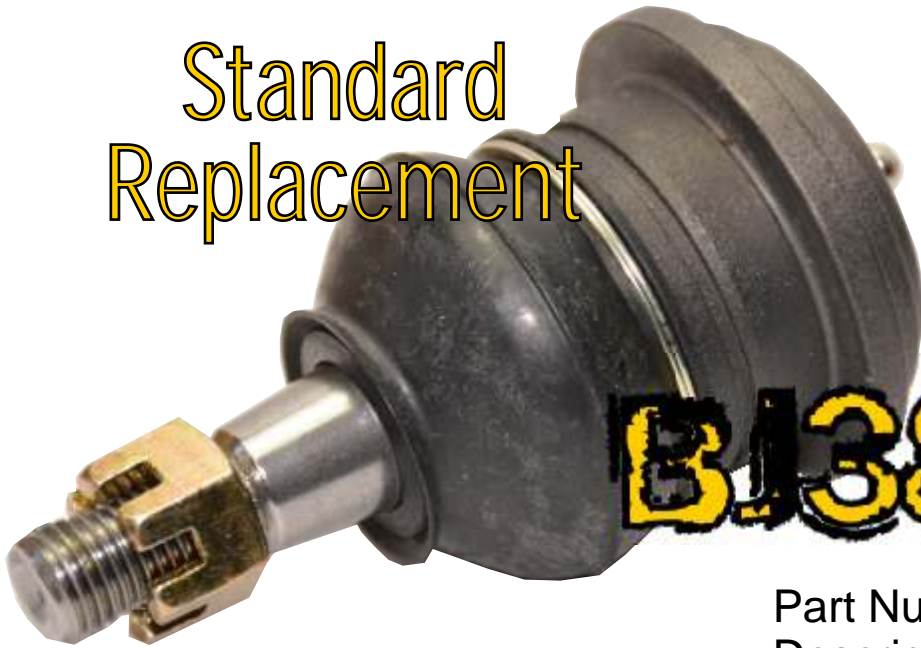
BJ3881HD

Now
Available
Greasable

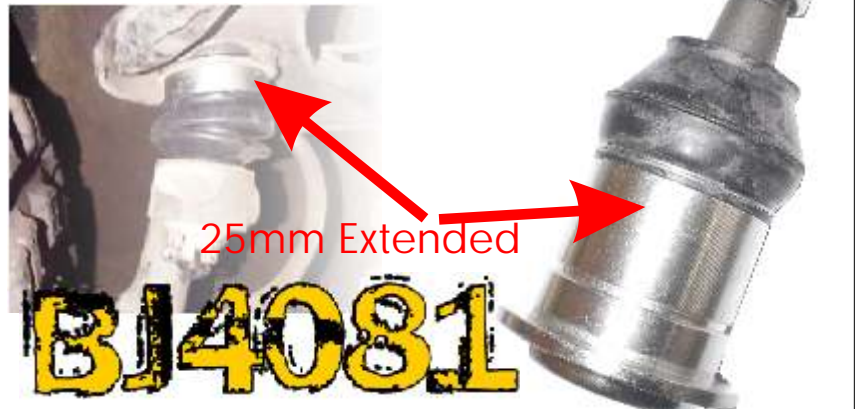
25mm Extended Ball Joint

If you have a lifted 05-on Hilux and during articulation you hear a clunk during full articulation, it might be the Front Upper Control Arm making contact with the Coil. Roadsafe have a 25mm extended Upper Ball Joint that fits to the Upper Control Arm, to space the arm far enough to avoid the factory upper arm contacting the coil on full droop. As an added bonus, it also provides an extra inch of downward travel, plus improves caster.
