Part Number—
SK411EXT
Hilux GUN (REVO)
8/2015-on

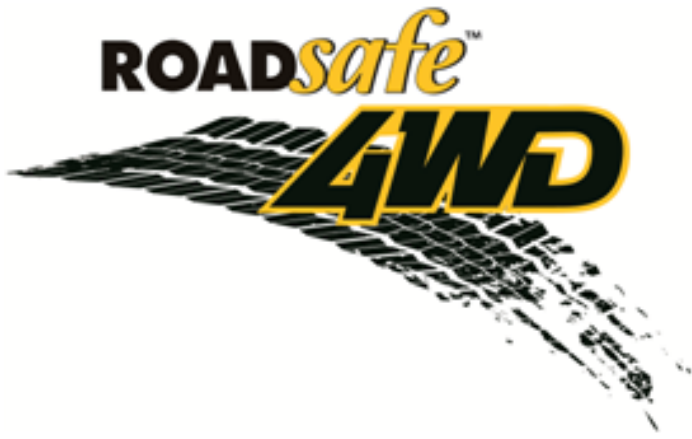
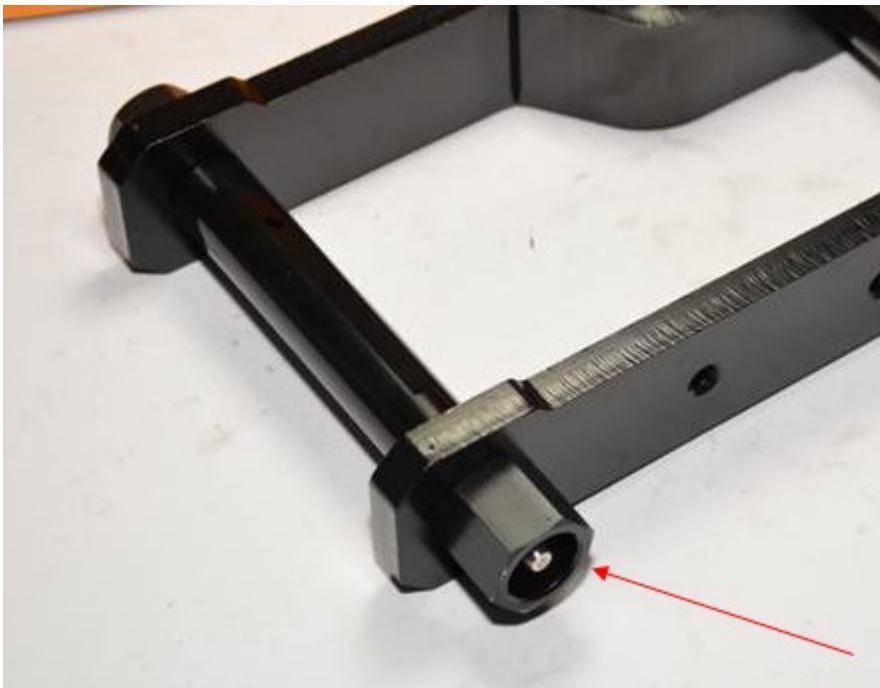
The new GUN extended shackles (SK411EXT) need to have the grease nipple protecting nut removed at the top pin to allow for the fitment of the head light aligning sensor bracket on the SR5 models.

This nut is only to protect the nipple, and not a structural part of the shackle.
