VEHICLE Toyota Land Cruiser 76 / 78 / 79 Series  
PRODUCT Bonnet Scoop Guard  
PART NUMBER BP103

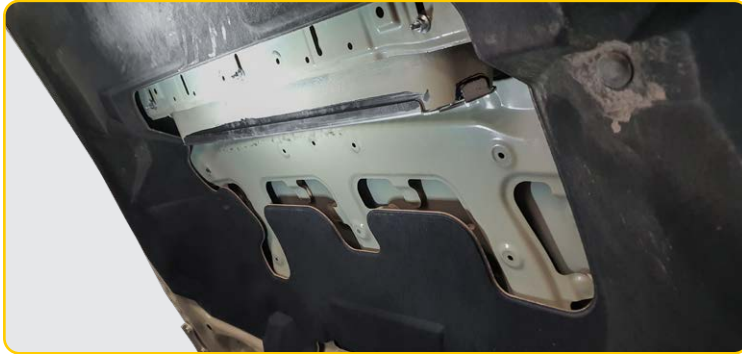
1. Remove the plastic/rubber under bonnet duct.

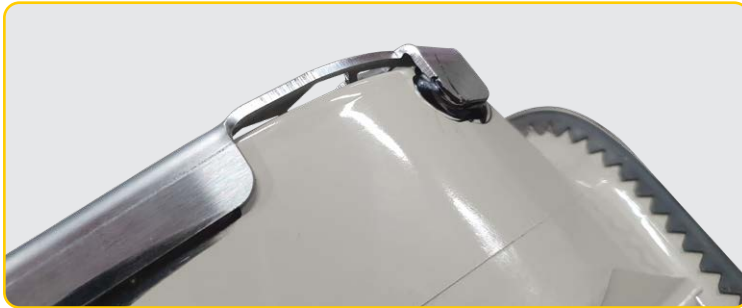
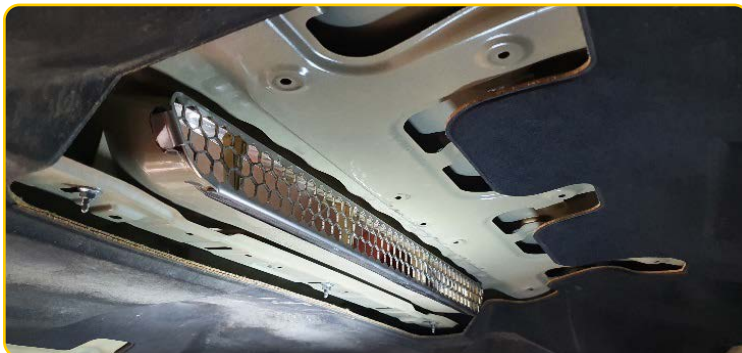
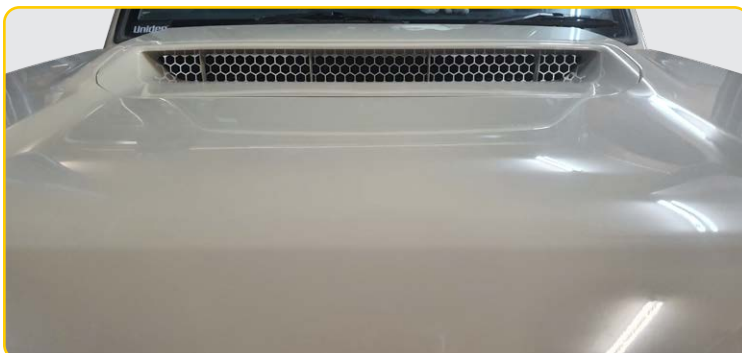
2. Apply Sikaflex to inner folded faces of stainless guard.

3. Place guard on inside of bonnet scoop.

4. Scoop is not 100% straight: it dips away at the ends. Ensure the guard is parallel to the centre section of the scoop.

5. Have tape to hold things in place while the Sikaflex cures as per instructions.

6. Refit inner duct under bonnet once cured.
